# CLEARING THE WATER AT BRITANNIA MINE

by Gerry O'Hara and Barry Azevedo

## Mining Environmental Management

April 2008

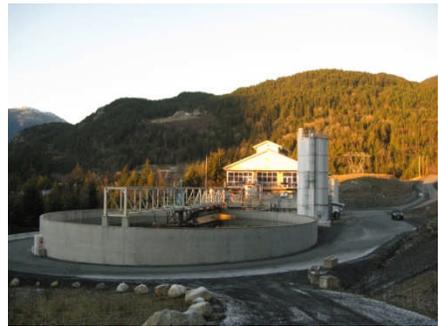
The water treatment plant removes metals from the mine water so it can be safely released into Howe Sound.

The Province decided on a Design-Build-Finance-Operate form of contract for procuring the water treatment plant and its operation, in a Public-Private Partnership in which the Province pays a pro-rated fee when the plant's discharge is within permitted limits. The initial contract called for the contracting company to operate the facility for 20 years. The technology was left to the proponents to choose, however, all proposals received adopted the accepted approach to Acid Rock Drainage (ARD) water treatment, ie. high density sludge (HDS) technology developed in the mid-1970s. This technology adds lime to the ARD water, which precipitates dissolved metals by pH adjustment. The water is then clarified before being discharged as treated effluent. The denser sludge is partly recycled into the inflowing water to seed crystal growth and make the clarification process more efficient. Surplus sludge, a stable metal hydroxide at 25 to 50 percent solids, is disposed of, or in some cases re-used in cement manufacturing.

Mine water flow figures over the previous 25 years were used to determine the size of the plant, which will treat an average of 97 percent of mine water. The three percent of mine water that is untreated will be discharged during by-pass events and will be neutralized by lime addition prior to being blended with the treated water stream, thus mitigating its
